**MARINE INVESTIGATION REPORT**  
**M05N0072**

**CAPSIZING AND LOSS OF LIFE**

**SMALL FISHING VESSEL *MELINA & KEITH II***  
**BONAVISTA, NEWFOUNDLAND AND LABRADOR, 70 nm E**  
**12 SEPTEMBER 2005**

Report Number M05N0072

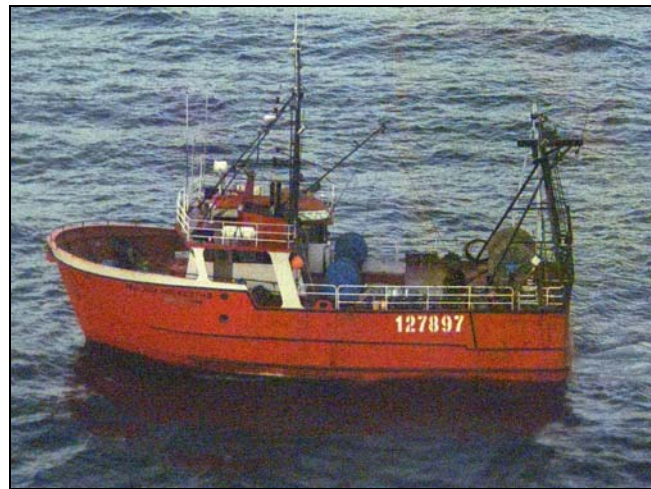
**Photo 1.** The *Melina & Keith II* following the work deck enclosure

The *Melina & Keith II* was one in a series of 65-foot fishing vessels, the first of which was built in 1982. Although similar in basic design, various modifications have been incorporated by individual owners. The *Melina & Keith II* was originally built with a work deck that was open to the environment. Due to the nature of the vessel, seas were frequently shipped, making for hazardous conditions on the work deck. The deck was fully enclosed in 2000, and four submersible pumps were installed for dewatering.

In 2000, the *Melina & Keith II* underwent major modifications that adversely affected its stability. TC did not request a stability assessment following the 2004 quadrennial inspection, nor did the owner.
